Indoor Air Quality Improvement in a School Building in Delhi

Maija Virta^{#1}, Suhaas Mathur^{#1}

[#]Santrupty engineers Private Limited

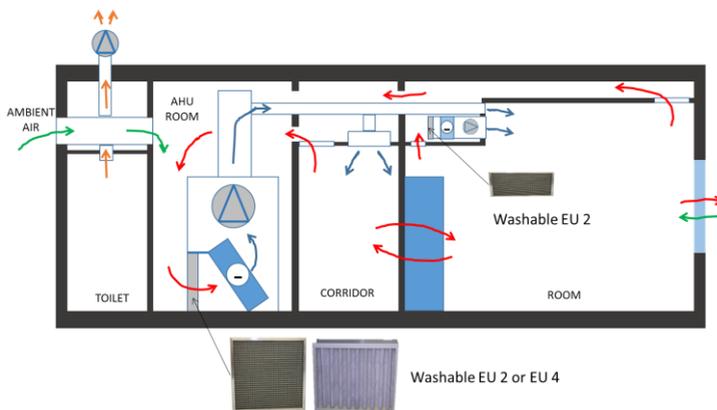
Each building has a mechanical ventilation system with cooling. The typical system consists of air handling unit (AHU) located inside an air handling unit room. Air handling unit is supplying the cooled air into the classrooms or apartments via ducts. The return air path is ceiling void and corridors. Fresh air intake is via a duct from the façade into the air handling unit room. Outdoor air volume is controlled by a damper in the end of the duct. Some of the classrooms and apartments have the additional fan coil units for local cooling. All air handling units had either EU2 or EU4 filters.

Fig. 1 A typical Air Handling Unit both in the school and residential buildings.

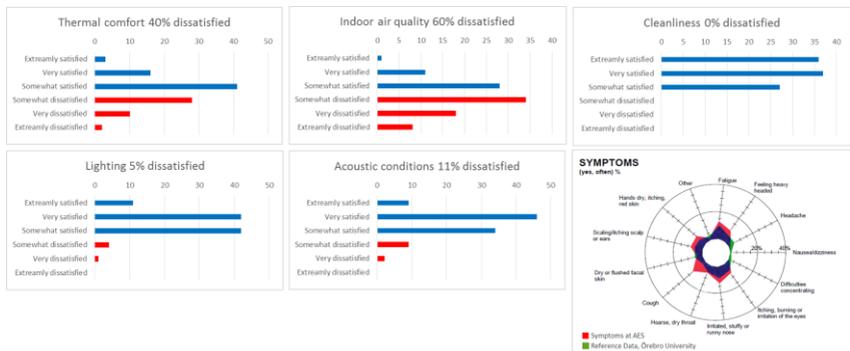
Survey results shows that the Indoor Air Quality (60% dissatisfied) and Thermal Comfort (40% dissatisfied) are the two major areas creating dissatisfaction among the users.

The user's health symptoms were compared with Orebro international data base (MM40). The only symptom that stands out is cough which may be due to high level of particulates and irritants in the respiratory system.

Fig. 2 Results of user satisfaction survey.

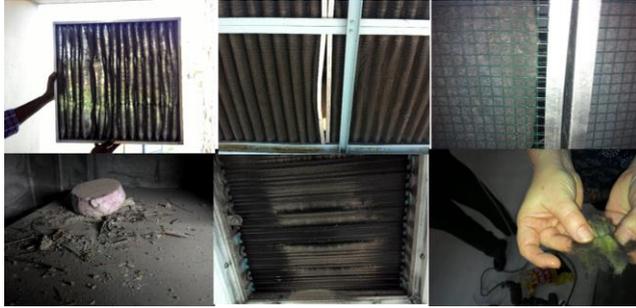
During the ventilation system performance review we measured air flow rates in each air handling unit and pressure loss across each component (filters, cooling coil and fan). Air flow rates in all air handling units were below design value. The current filtration G3+G4 was not sufficient to remove RSPM. The pressure loss across the filter section was very low, about 40-100 Pa only, indicating the poor quality of current G4 filters. This was confirmed with visual inspection – there were lots of damaged filters and due to the regular washing, the filter media had worn out.

Fig. 3 There were lots of problems with current ventilation system operation and filtration.

Based on the pressure difference evaluations between various rooms (measurements and smoke demonstrations), most of the classrooms were not in positive pressure, as designed, and some of the rooms did not have air supply at all. Ducts were dirty as they had never been cleaned since buildings were constructed. Some fan motors were not working and belts were damaged. Loose mineral wool was found inside the ducts near the air handling unit. Many air handling unit rooms were also used as a storage room.

The following recommendations were made to improve IAQ and system performance in the school campus. Room air particulate and CO₂ levels as well as temperature were too high. To improve air quality, ambient air and AHU filtration needs to be improved, buildings needs to be properly over-pressurized to avoid ambient air from entering indoors via windows and doors and each room to have the sufficient amount of supply air.

Maintenance and operation of ventilation system needs to be improved. HVAC-system components (including AHU rooms) need to be maintained at a high standard. Operation and maintenance personnel need additional training to better manage the operation of ventilation and air conditioning

The ventilation system required lots of small repairs and maintenance activities. All air handling unit rooms were cleaned and sealed properly. New G4 filters were installed to all air handling units. Some ductwork modifications were done. All loose mineral wool surfaces were covered inside the air handling units and ducts. Ducts and diffusers were vacuum cleaned.

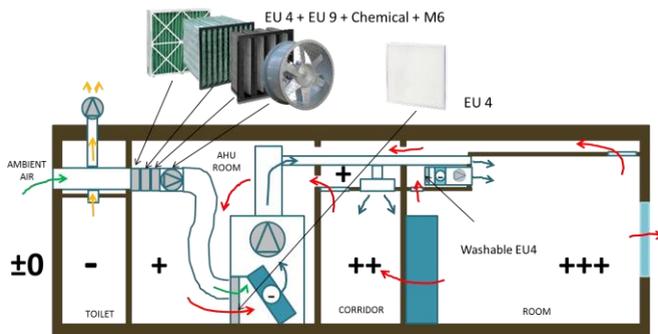
Ambient Air Purifier (AAP) is a fan-filter unit that cleans the outdoor air before it is supplied into the AHU room. Building has 9 AHU rooms, so 9 AAP units were designed in sizes between 250 – 1,000 l/s. Each unit was designed to supply 1.5 l/s,m² of fresh air (15% of the total air handling unit air volume), which gives the air exchange efficiency of 2 air changes per hour. Each unit has a place for four filters: washable G4 filter, F9 fine filter, chemical filter and M6 post-chemical filter. This shall give the filtration efficiency that is more than 99% for $PM_{2.5}$, 100% for PM_{10} and remove gases from outdoor air.

Fig. 4 The ambient air purifier is installed to clean the air before supplied into the air handling unit room.

The selected solution consists of retrofitting an ambient air purifier into each AHU room, repairing and cleaning the ventilation system, balancing the ductwork and improving the system maintenance.

Therefore we added another coarse filter M5 between G4 and F9 filters to the rest of the buildings at the school campus in order to improve coarse dust filtration. This increased the life cycle of the more expensive fine filter. We also advised the maintenance team to keep the ambient air purifier units switched off until the filters are dry in case they want to wash them.
